Miscellaneous Paper SL-96-1
February 1996

Forced Entry Testing of Five-Minute Walls

Prepared for U.S. Department of State,
Office of Foreign Building Operations

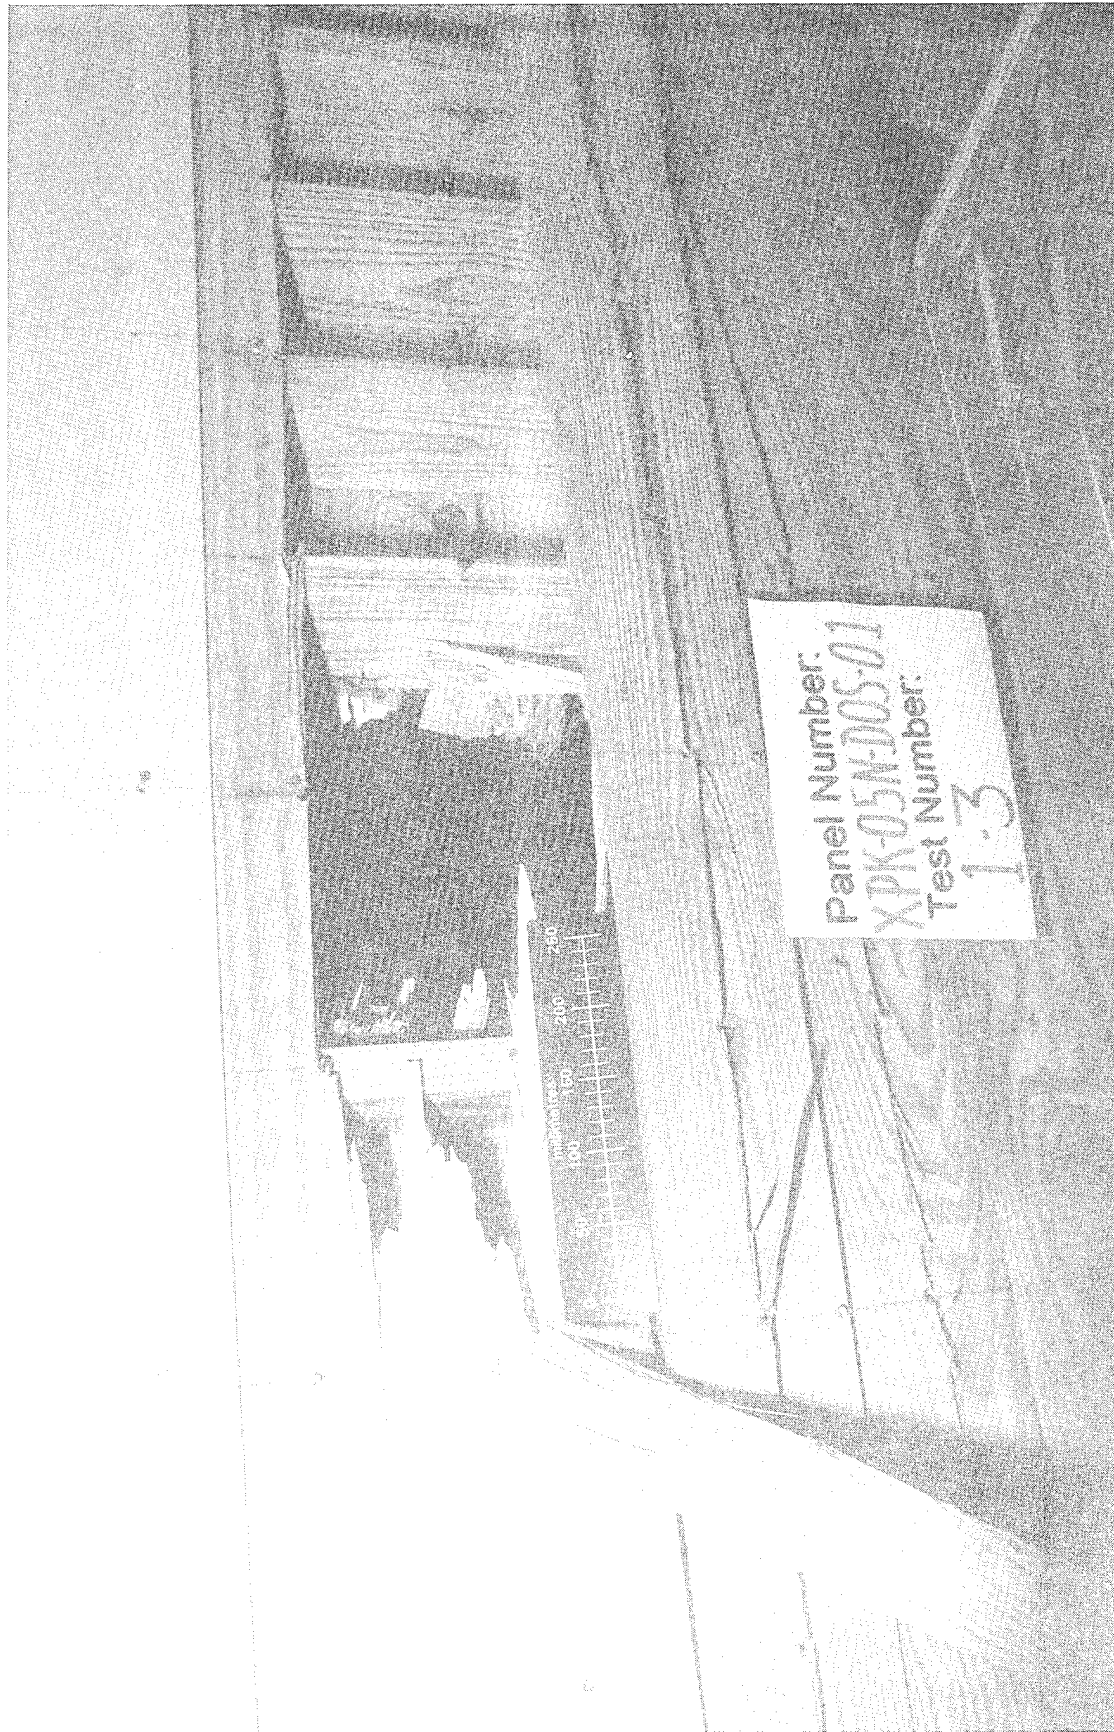
The assault began at 10:55:00 on 31 May 95 with the assault team using sledgehammers. The sledgehammer assault continued until 10:57:32 when the assault team began using the ram to break loose the wood board sheathing on the protect side of the panel. (The protect side is opposite the assault side of the panel.) After using the ram for approximately 8 seconds, the assault team returned to the sledgehammers which they used until 10:58:35 when they pushed the metal box completely through the opening in the panel. The total penetration time was 3 minutes and 35 seconds. Posttest photographs of the opening in the panel are presented in Figures 32 and 33.

Figure 32. Assault side of panel XPK-05N-DOS-01 after test 1-3

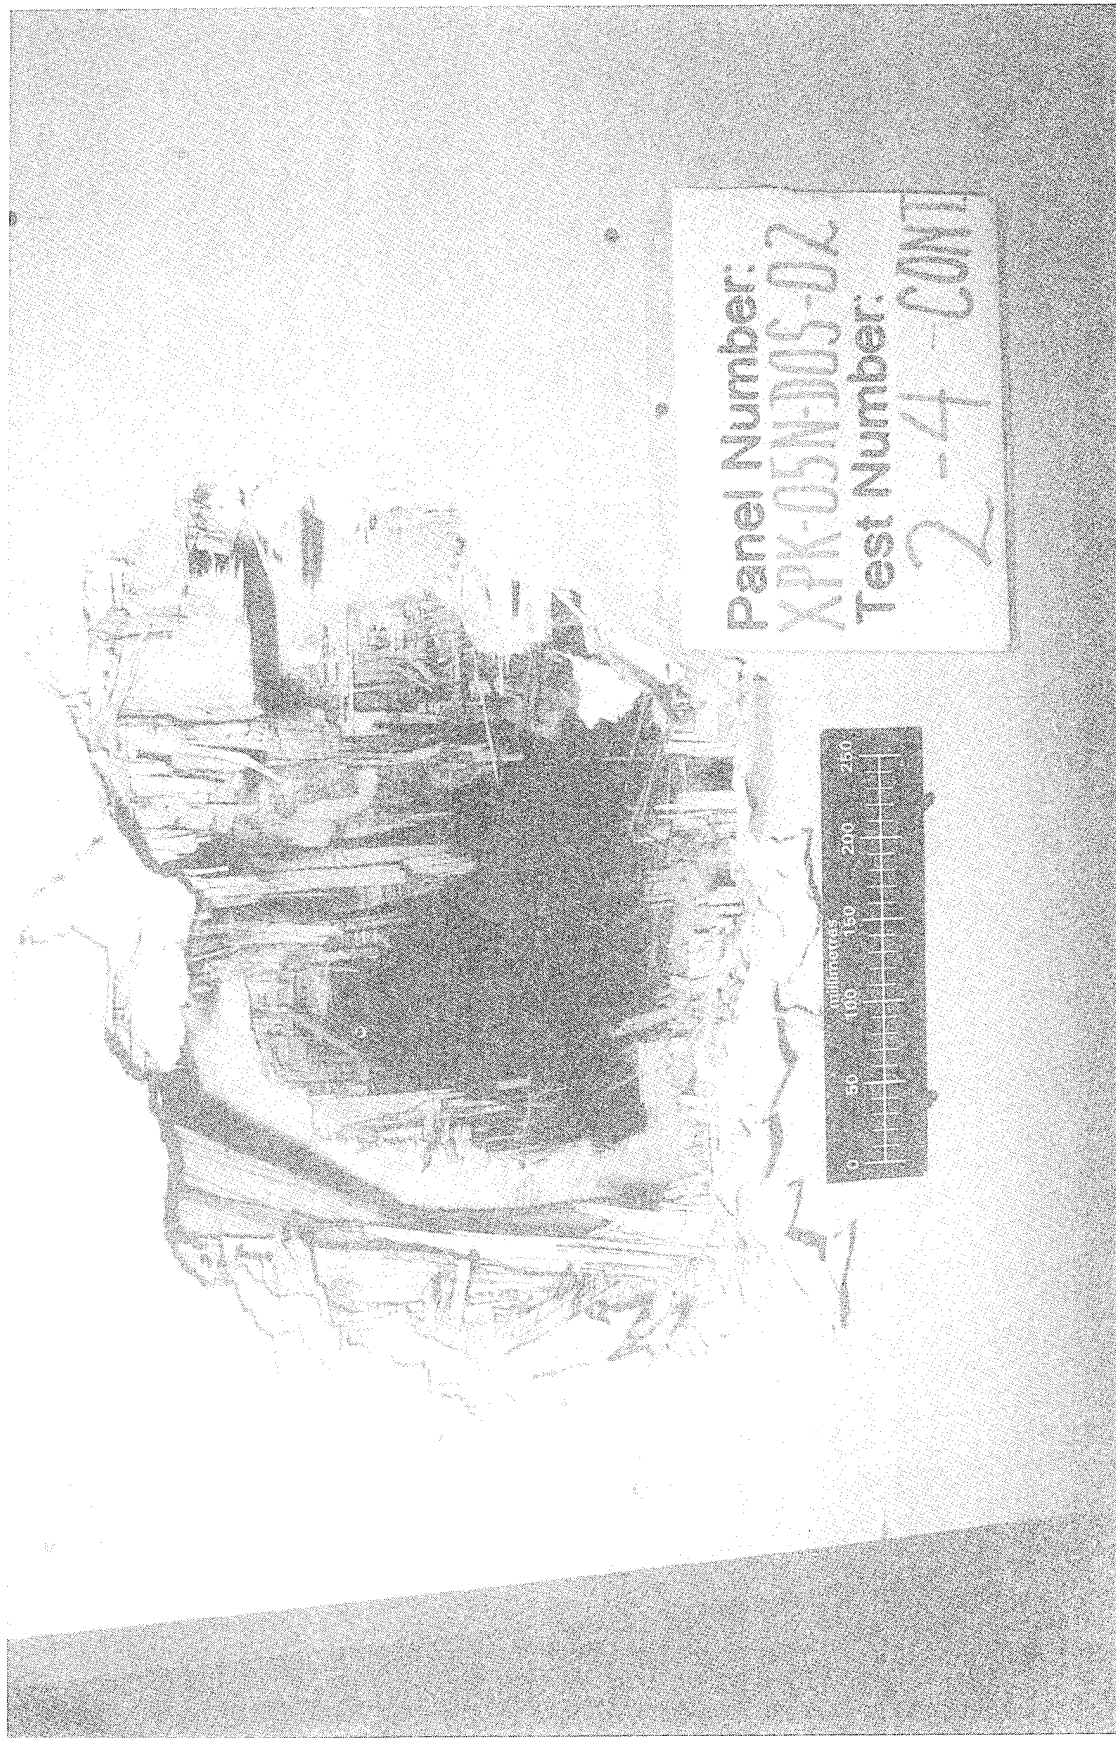
Figure 43. Protect side of panel XPK-05N-DOS-02 after the initial assault phase of test 2-4

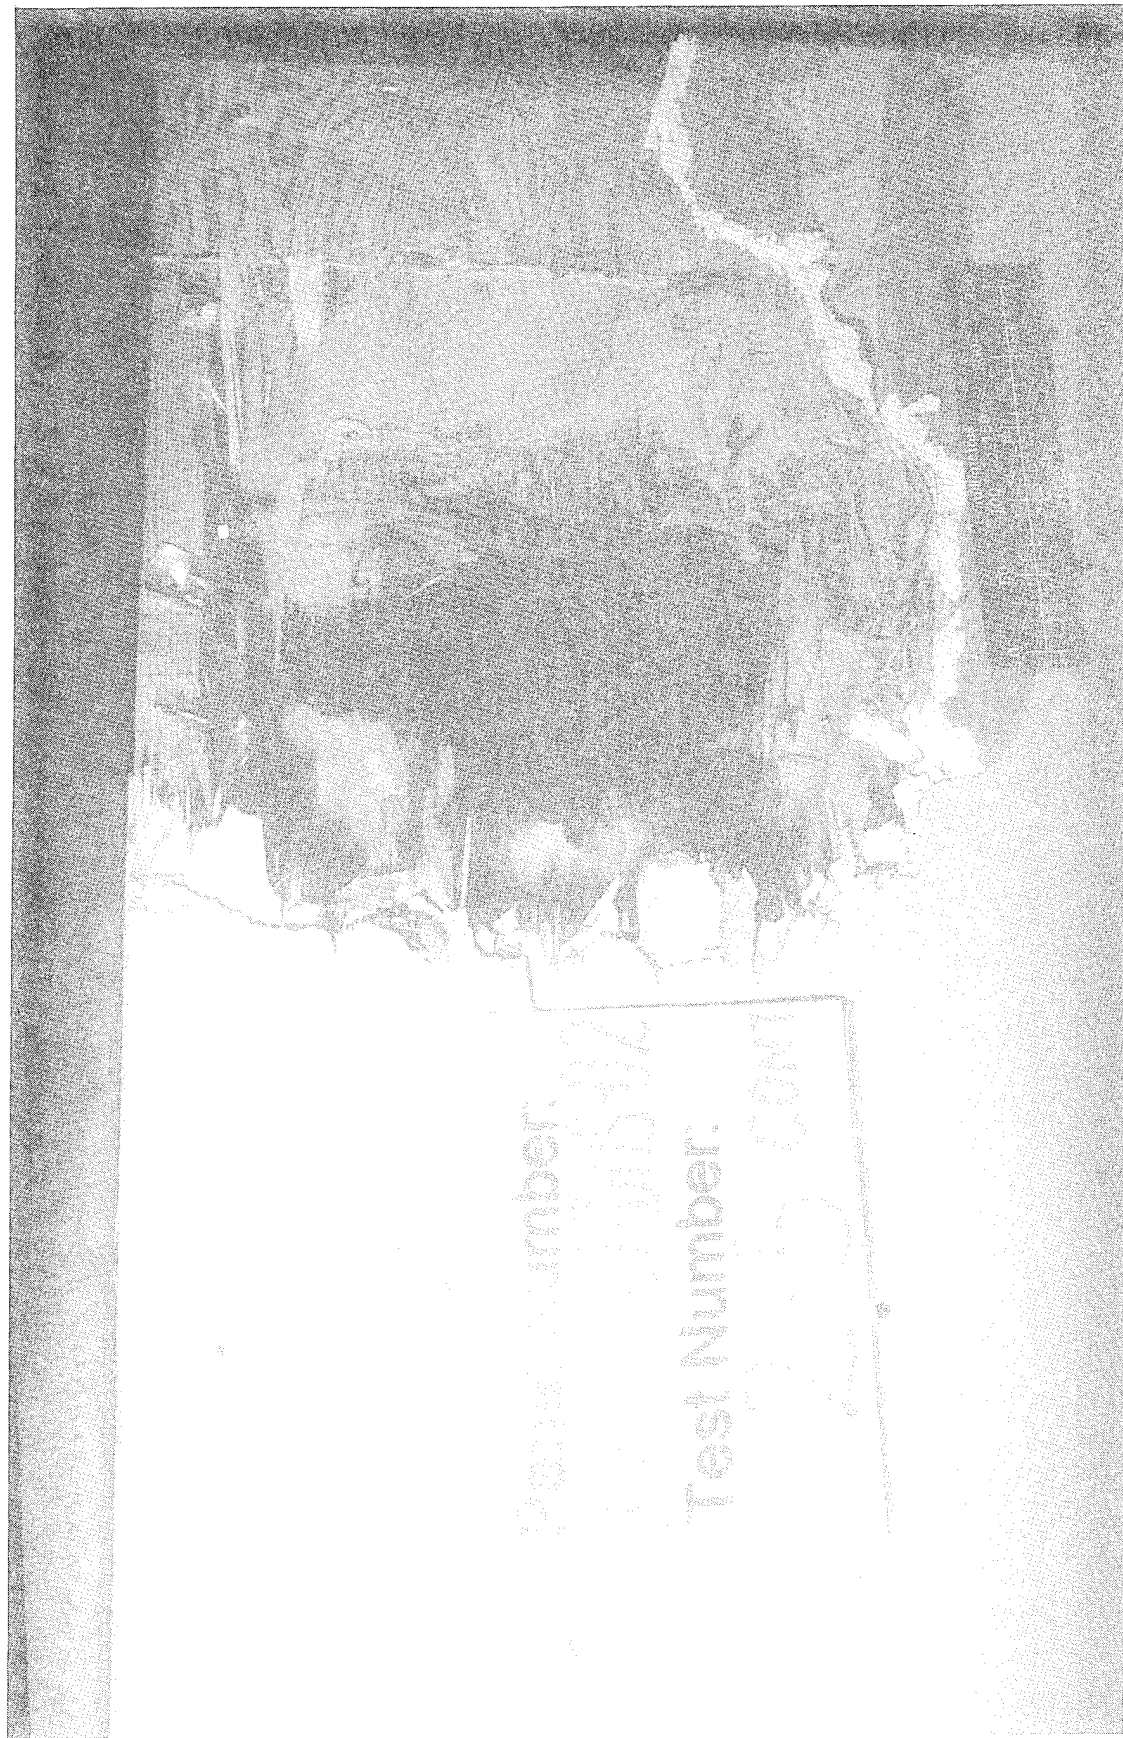
Figure 47. Protect side of panel XPK-05N-DOS-02 after the initial assault phase of test 2-5

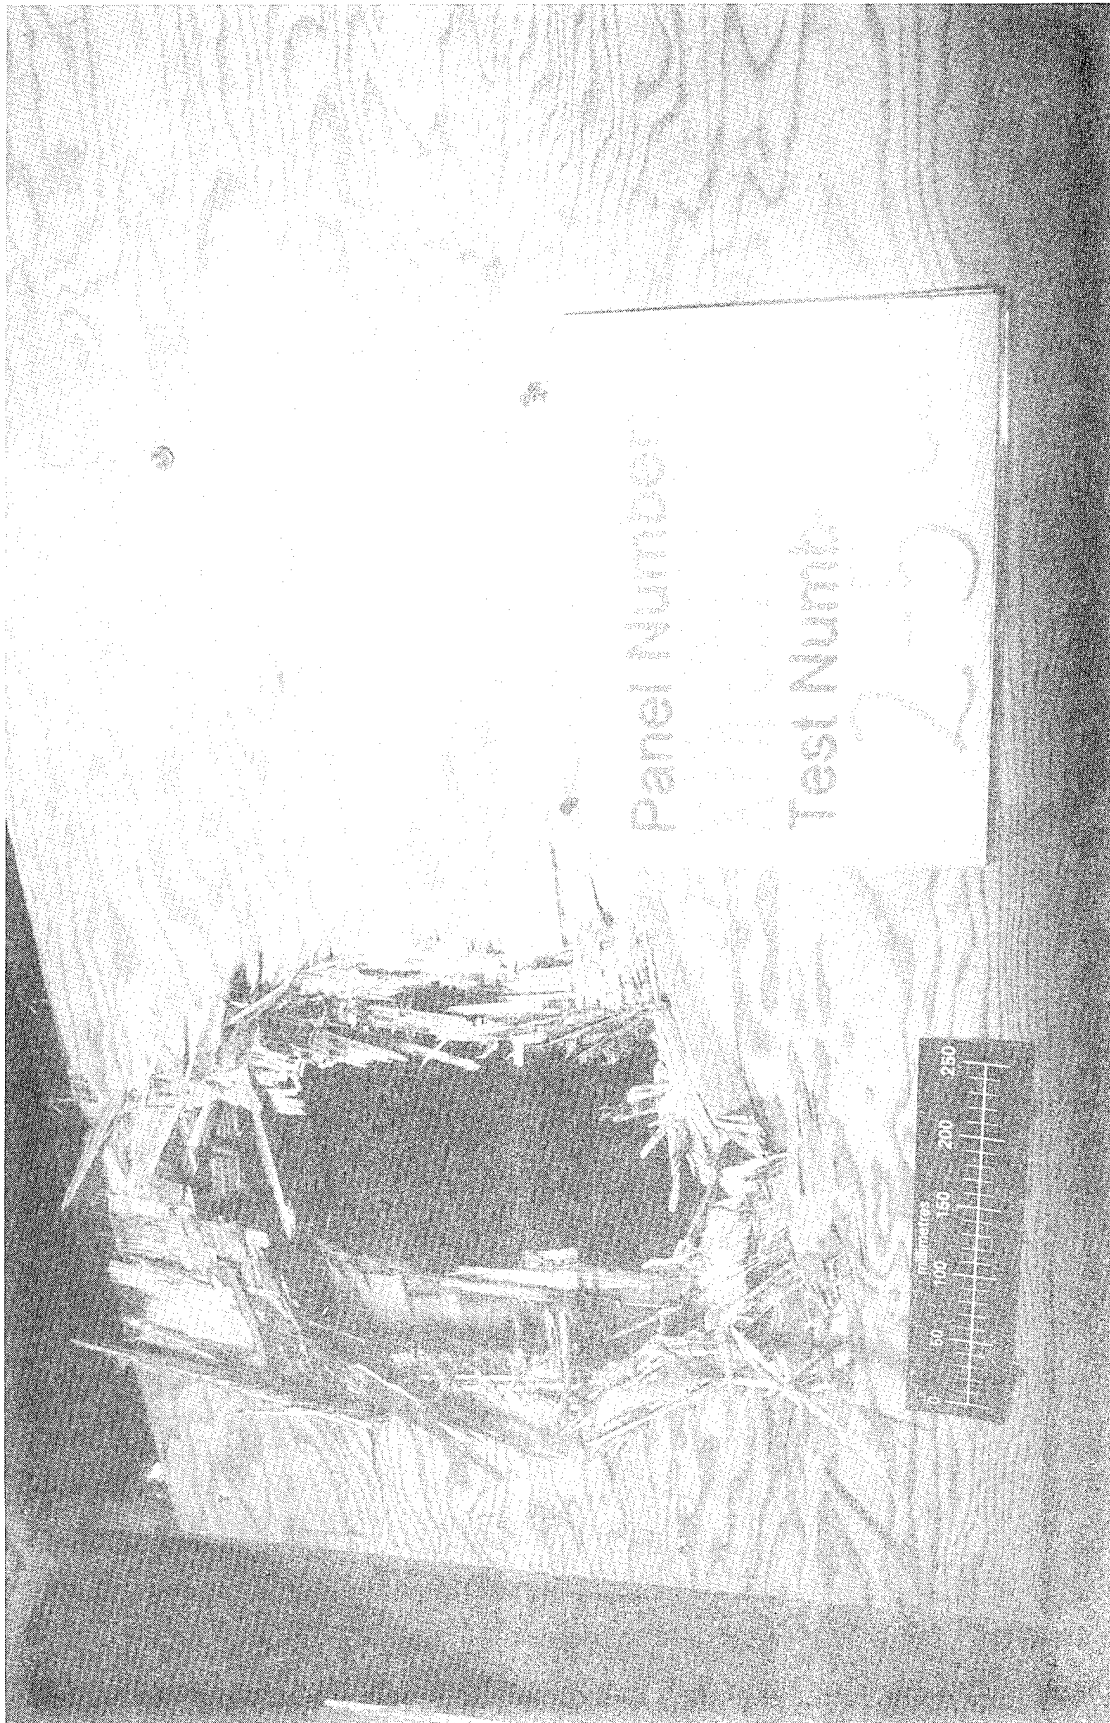
Figure 48. Assault side of panel XPK-05N-DOS-02 after the second assault phase of test 2-5

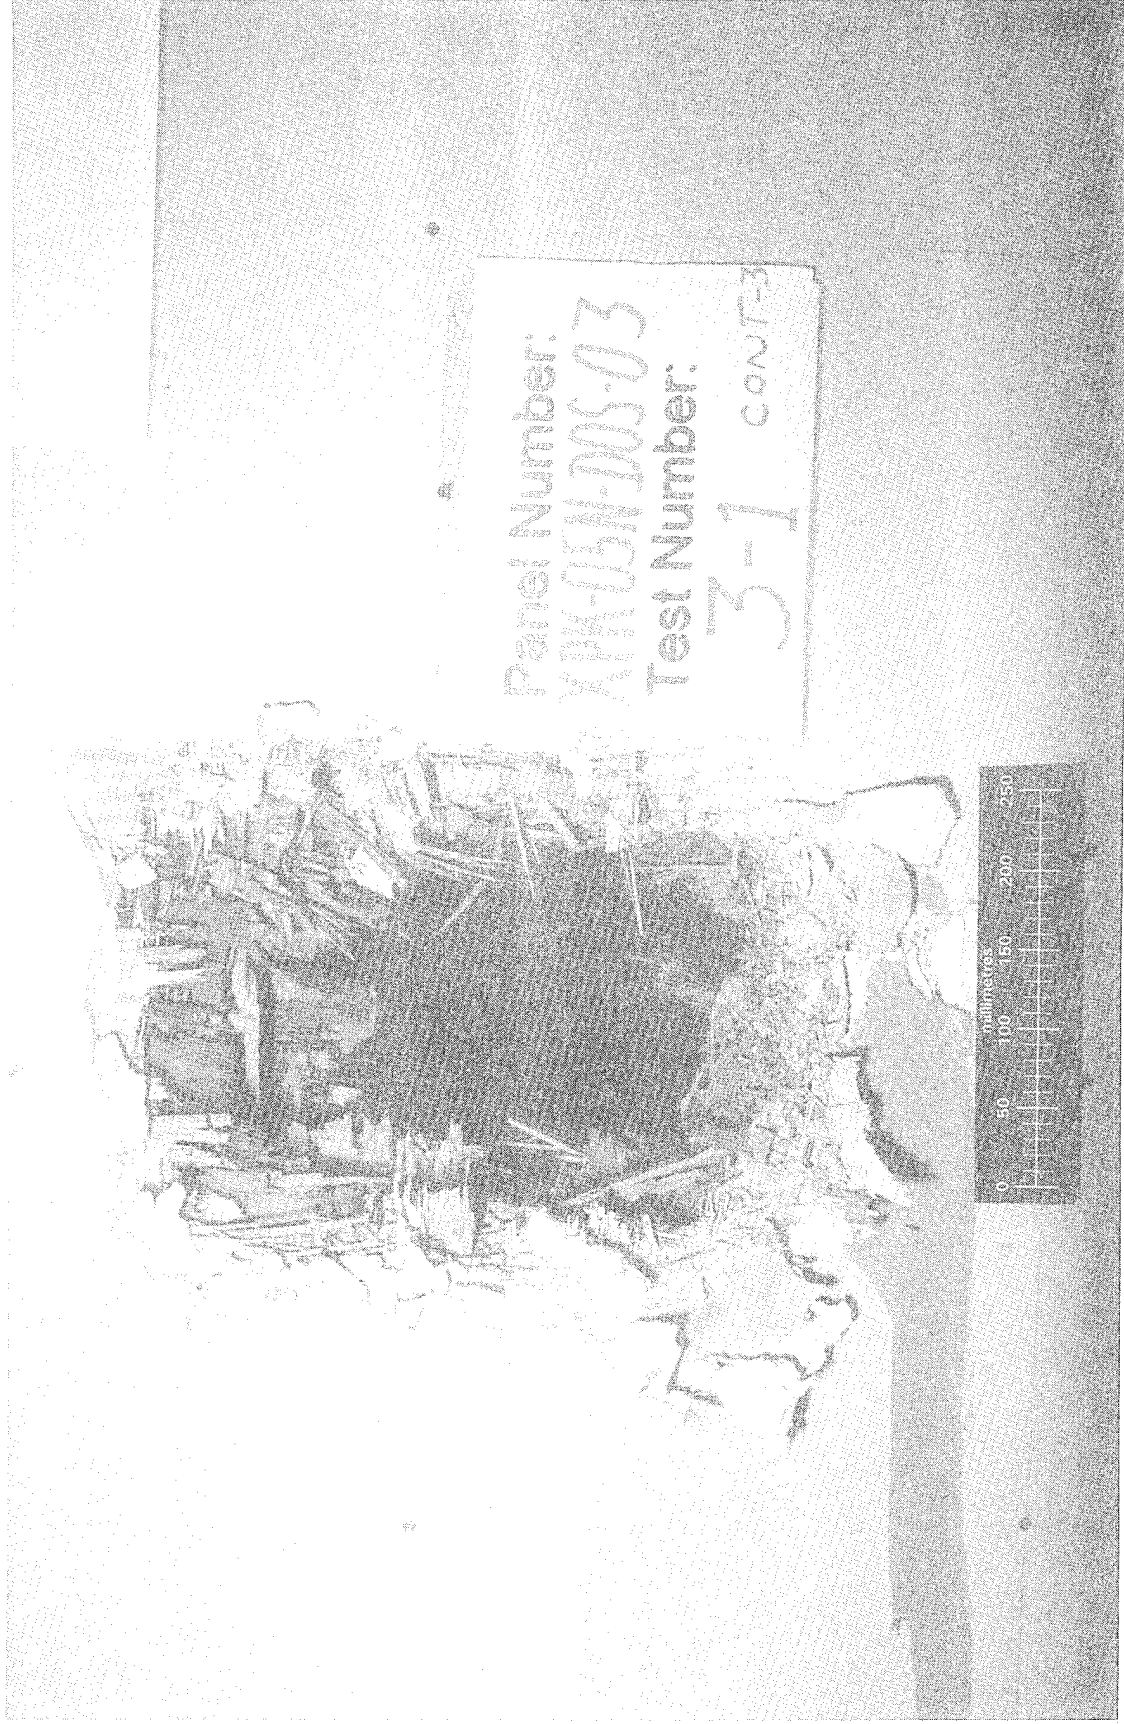
Figure 52. Assault side of panel XPK-05N-DOS-03 after the second assault phase of test 3-1

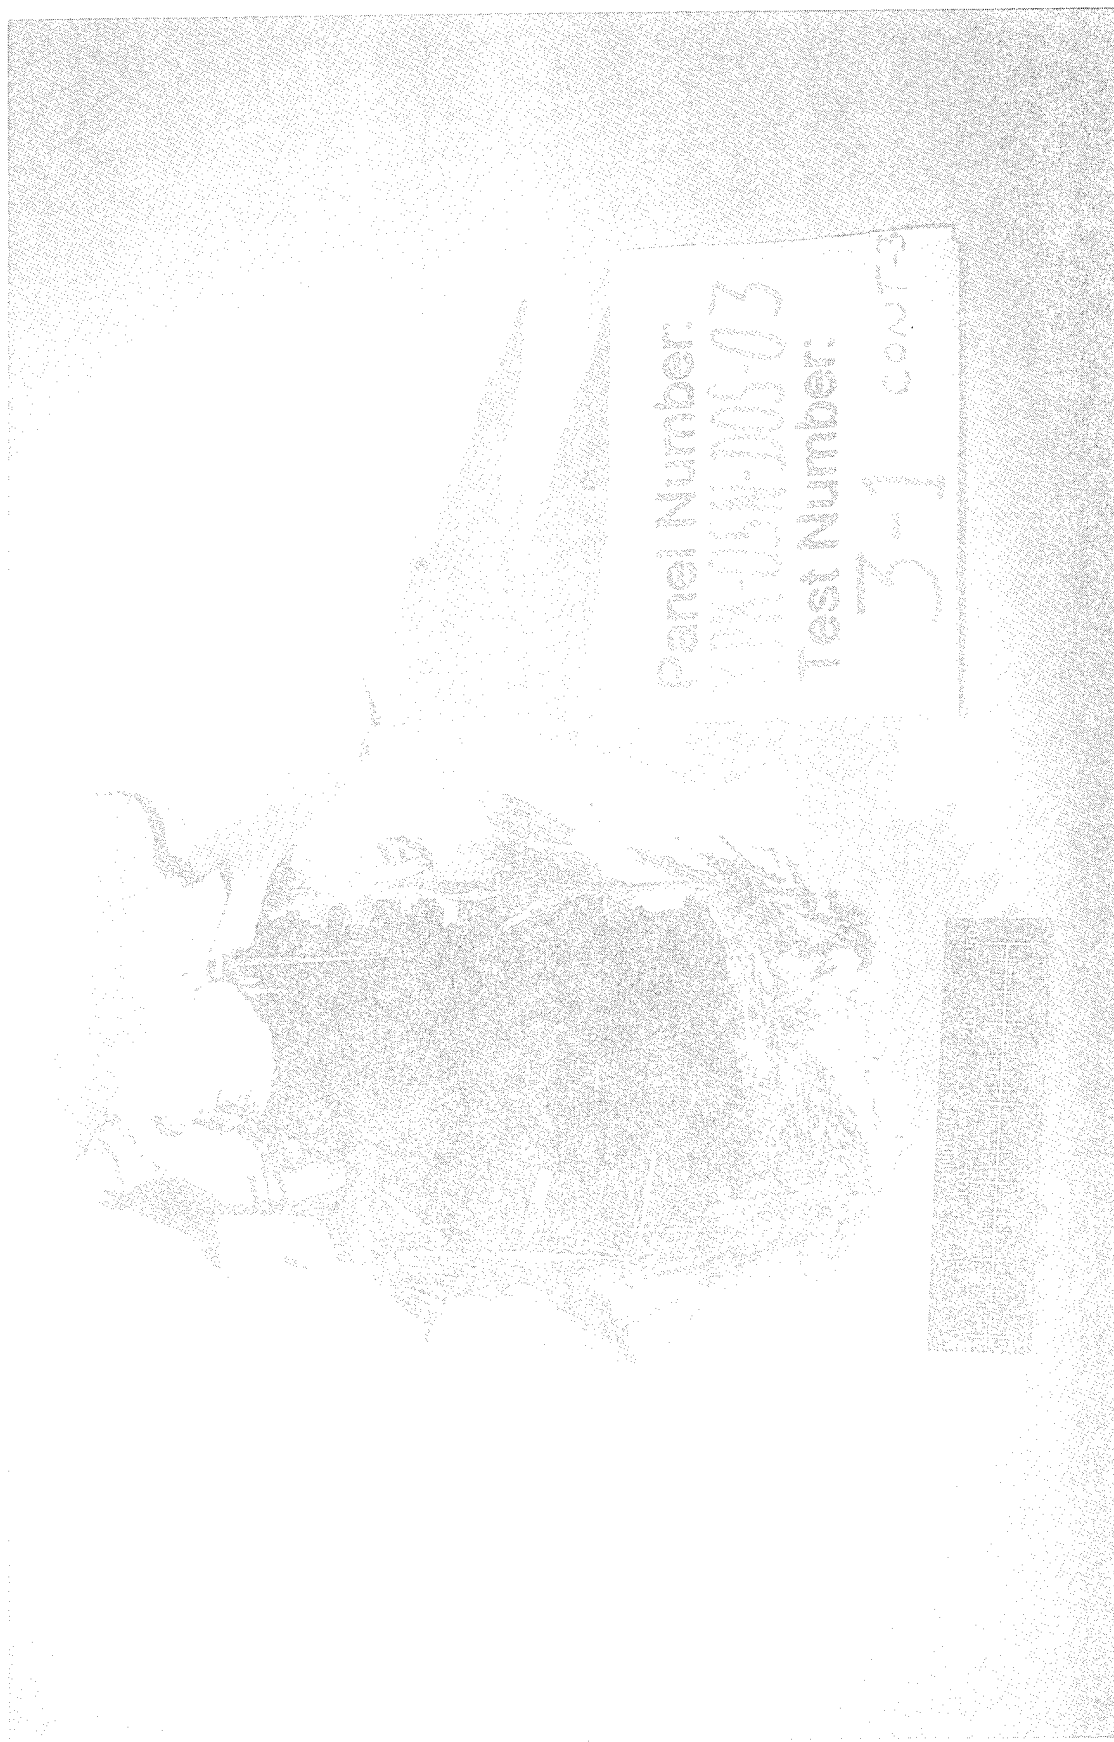
Figure 53. Assault side of panel XPK-05N-DOS-03 after the third assault phase of test 3-1

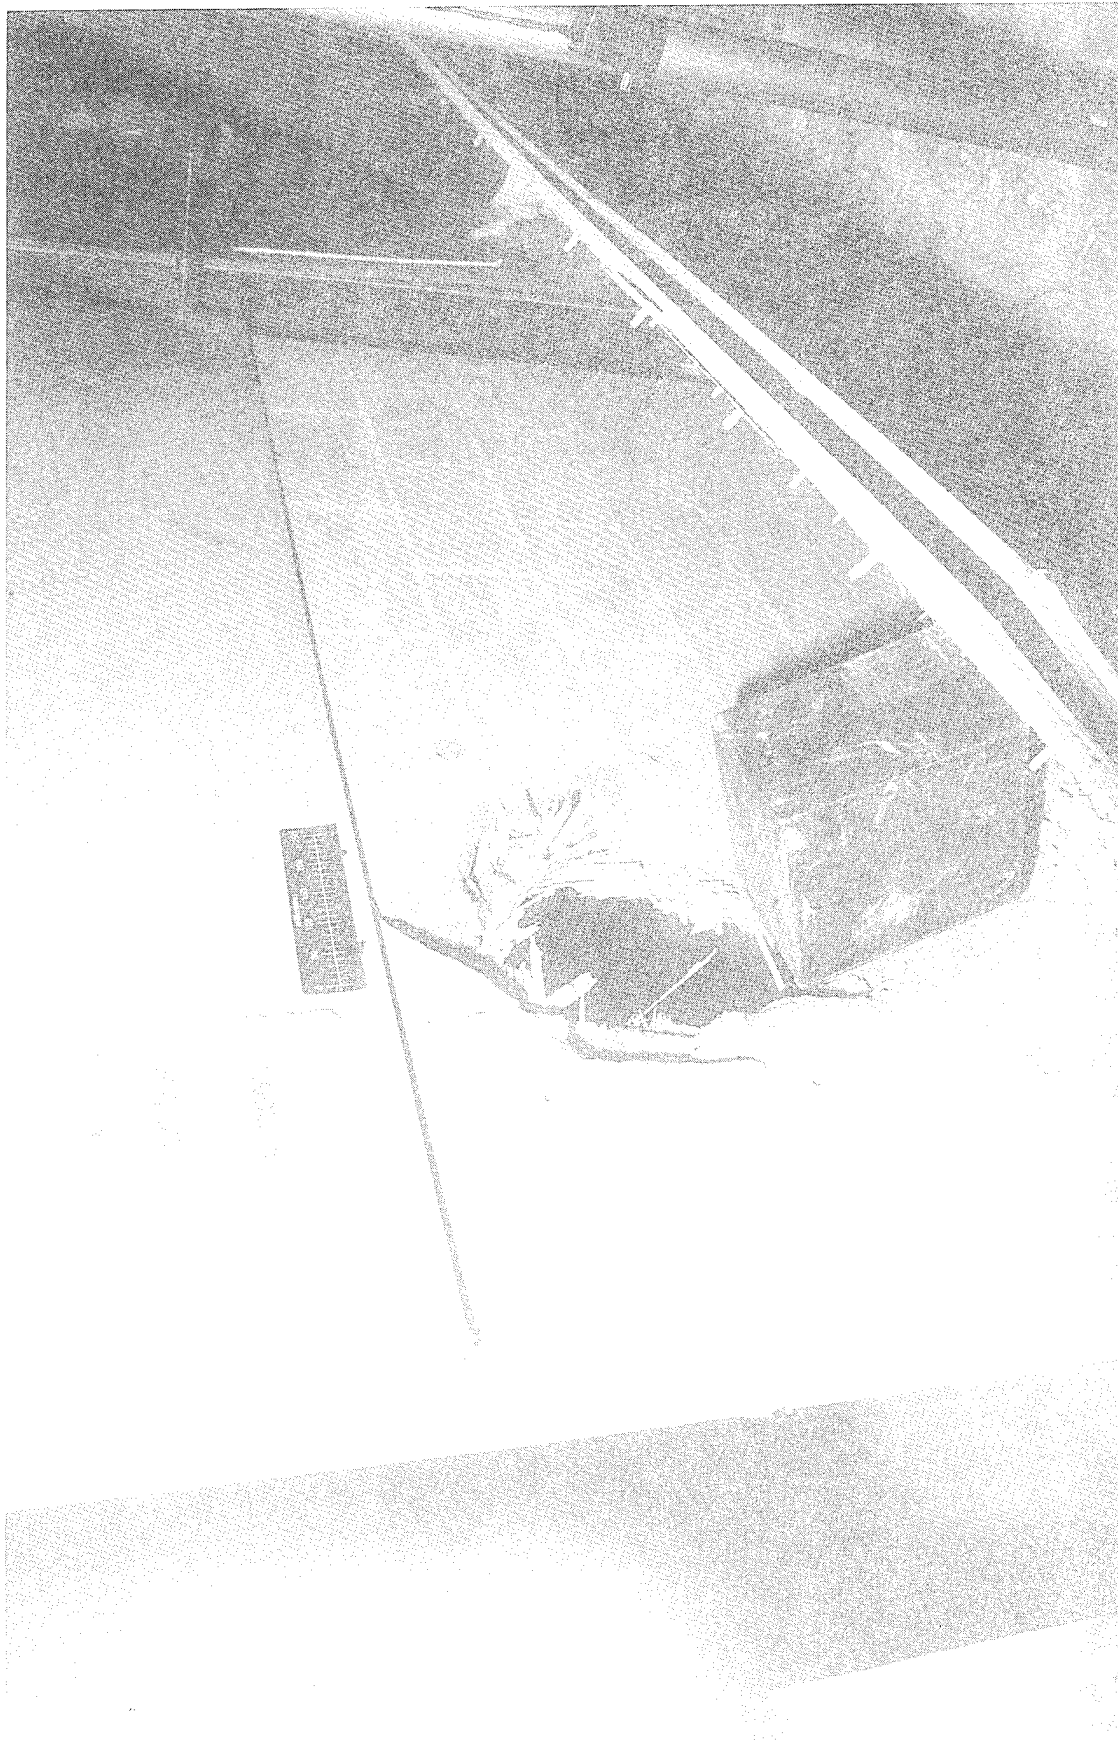
Figure 59. Assault side of panel XPK-05N-DOS-06 after test 6-1
